Permit #	Deficiency ExteNet Must Correct	Public Works Inspection Photograph	ExteNet Simulation	ExteNet Plans
1680 Powell St. / 14WR-0017	A disconnect switch was installed that is larger than the switch approved in the plans/sims			
826 Vallejo St. / 14WR-0026	A disconnect switch was installed that is larger than the switch approved in the plans/sims

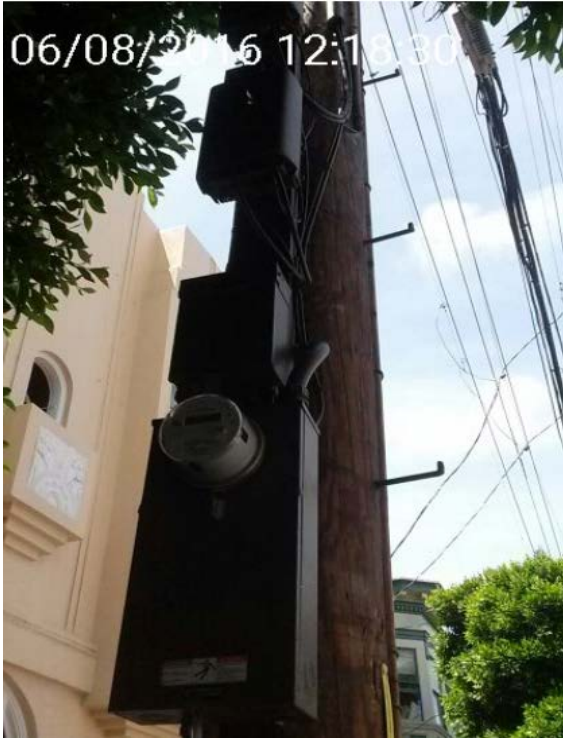
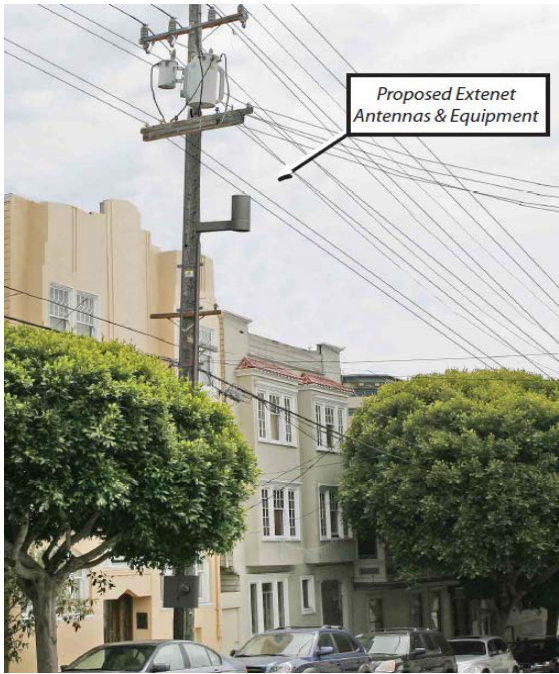
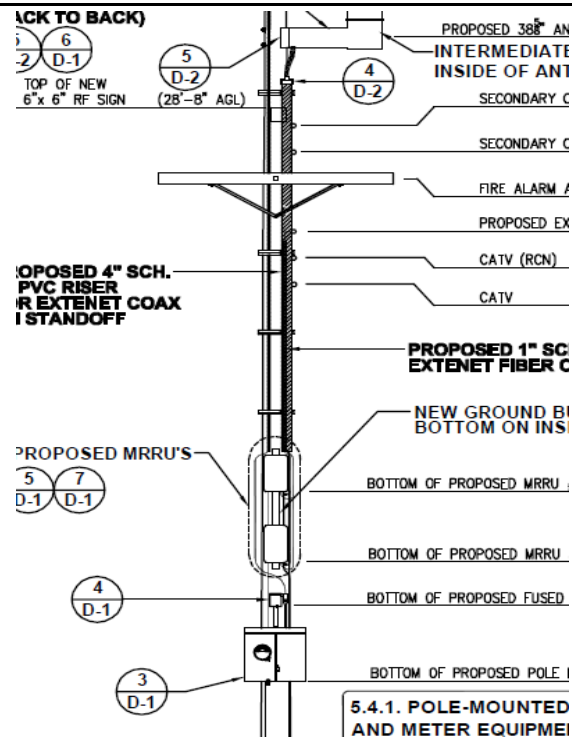
Permit #	Deficiency ExteNet Must Correct	Public Works Inspection Photograph	ExteNet Simulation	ExteNet Plans
1267 Green St. / 14WR-0125	A disconnect switch was installed that is larger than the switch approved in the plans/sims
